MP 3500 Grounding Plate

NATT #: 02037006

Background Information and Discussion of Problem:

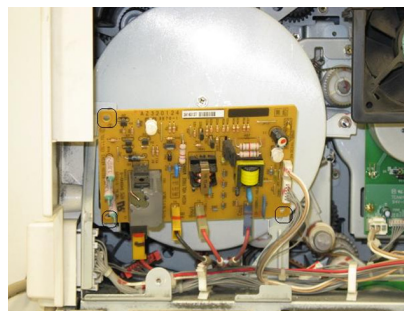
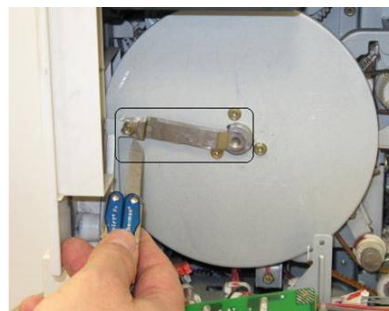
Symptoms may include: a floating ground between 0 and 2.7 ohms, dirty-running machine, fuser cleaning roller building up toner quickly, and premature drum wear due to residual charge left on the drum.

The cause of this problem is the intermittent ground through the drum bearing, OEM #: 08053441. As the bearing ages, the grounding wire within the bearing wears, which reduces contact for ground.

NA Trading and Technology has worked with Ricoh family dealers to reduce grounding issues through the drum bearing. The NATT Grounding Plate is designed to mount on the PC Board's ground screw and provides a contact directly to the drum shaft.

Testing confirms that ground measures 0 ohms with the plate installed.
