Subject: Ricoh* Pro C5100/C5110 and MPC 6502/8002 D1 Lever repair

NATT #: 02042005 (pack of 5)

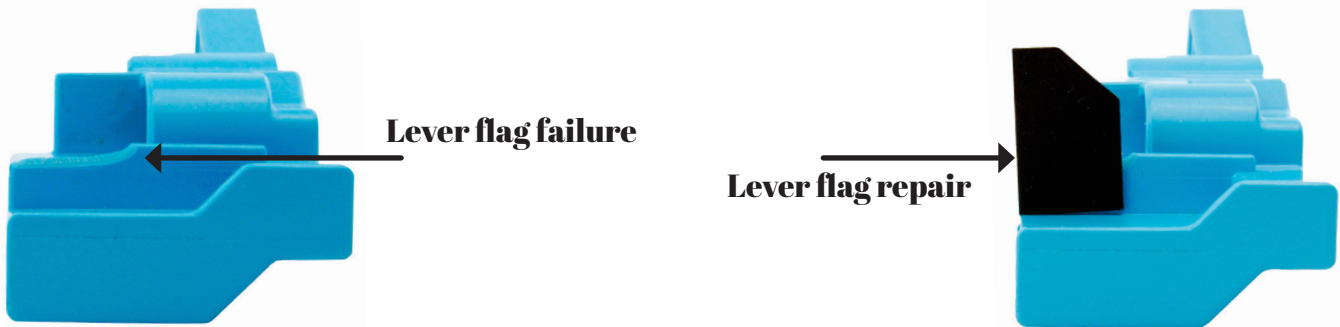
Discussion of the Problem, Part 1: The D1 lever (OEM #: D136-3864) in the Ricoh Pro C5100, Pro C5110, MPC 6502 and MPC 8002 features a flag to disrupt the photo interrupter. Unfortunately, the thin flag is prone to failure, and the machine shuts down as a result.

Solution 1: Rather than replace the lever, you can simply use an inexpensive repair we created. A simple tab applied to the flag with Very High Bond adhesive from 3M* will perform the flag's function.

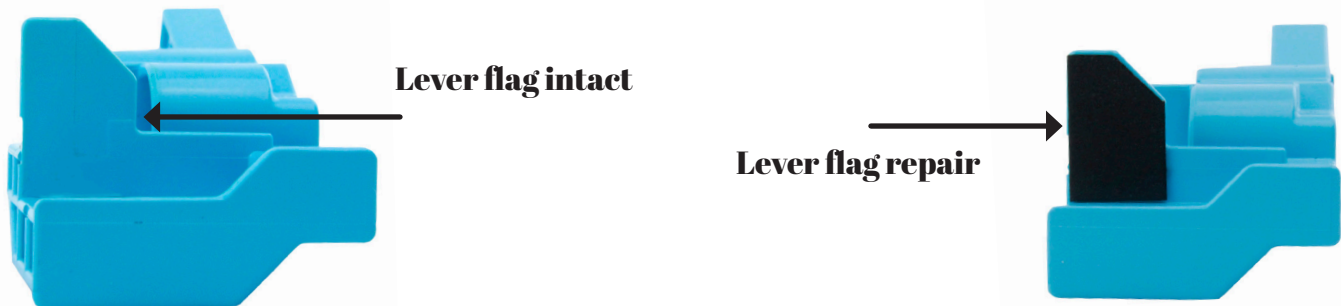
Discussion of the Problem, Part 2: Your Ricoh Pro C5100s/C5110s D1 lever is flawless, but you worry it will break between scheduled service visits, necessitating costly unscheduled maintenance.

Solution 2: If the flag is intact, our repair will reinforce it. The flag will be less likely to break, and if it does break the repair is designed to disrupt the photo interrupter. Avoid a possible service call in the future for less than the cost of a cup of coffee.
