## Feed Belt Traction Strip

**NATT #:** 02012000 (Pack of 5)

### Background Information and Discussion of Problem:

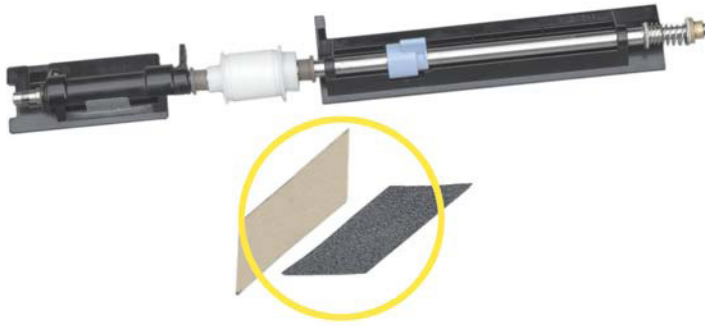
## 1. Test for Size

Before Removing the protective sheet, prewrap the NA Traction Strip around the roller and, if needed, cut down to size. Be sure to cut parallel with the existing end to ensure the best fit.

Note: There should be a 3mm gap between the ends after trimming. When the protective wrap is removed, there will no longer be any significant gap.

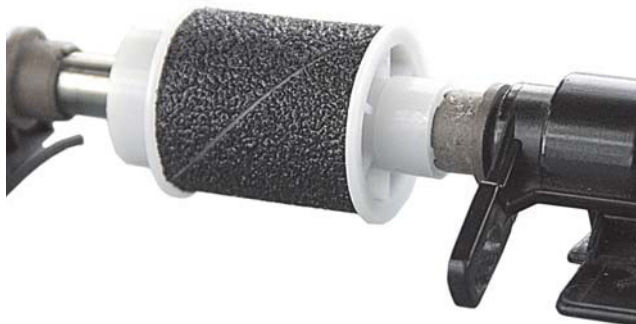
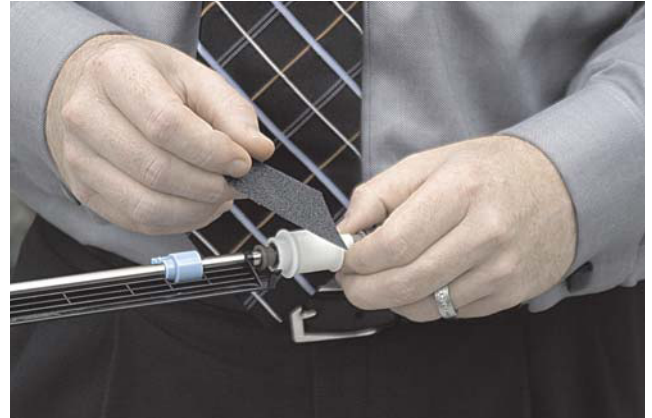
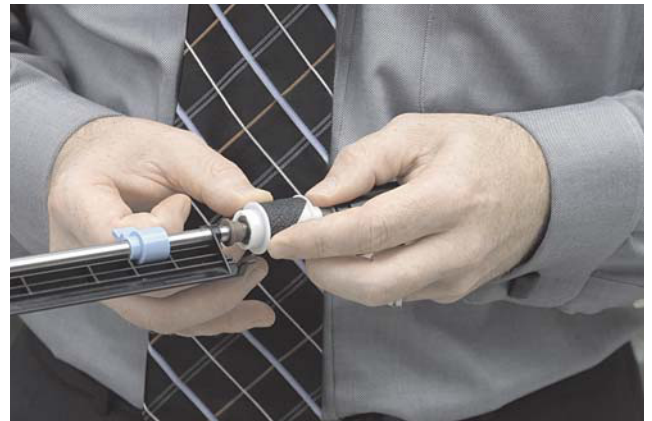
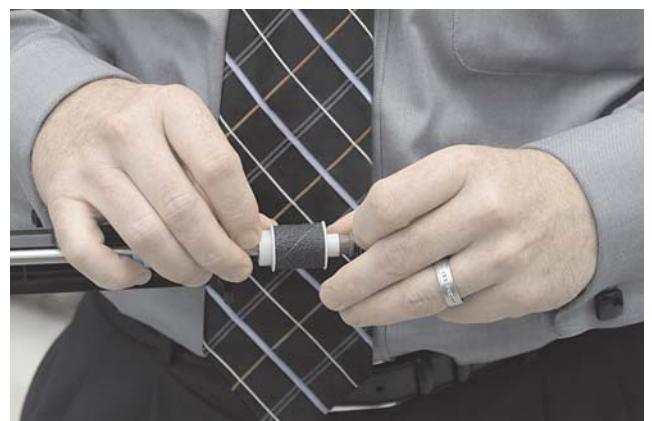
## 2. Place Strip on Roller

Remove the protective paper and carefully place one end of strip on the plastic roller and wrap it around, smoothing as you go.

There should be only a tiny gap between ends when you are complete.
