MP 4000 Grounding Plate

NATT #: 02037011

AF MP4000/ AF MP4001/ AF MP5000/ AF MP5001/ AF SP8200DN/ 9040/ 9050/ 9240
9250/ MLP150DN/ LD040/ LD050/ LD140/ LD150/ LPN150DN

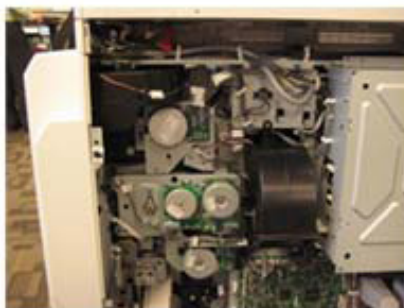
MACHINE REAR

NA Trading's Grounding Plate mounts on the rear frame of the machine in place of the existing grounding plate (OEM #: D0091121), providing contact directly to the drum shaft instead of through the bearing race.

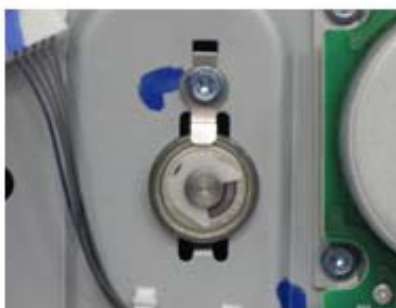
OEM PLATE

Intermittent and unreliable ground through the drum bearing, OEM #: B2421161, reduces machine performance.

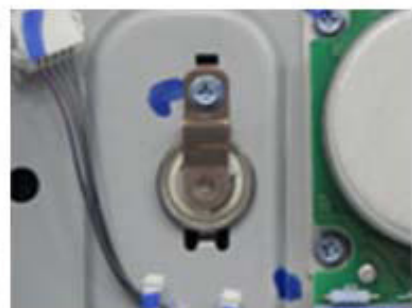
NATT PLATE

Testing confirms that ground measures 0 ohms with the plate installed.
